INDOOR AIR QUALITY ASSESSMENT

**William Gould Vinal Elementary School
102 Old Oaken Bucket Road
Norwell, MA**

Prepared by:
Massachusetts Department of Public Health
Bureau of Environmental Health
Indoor Air Quality Program
March 2017

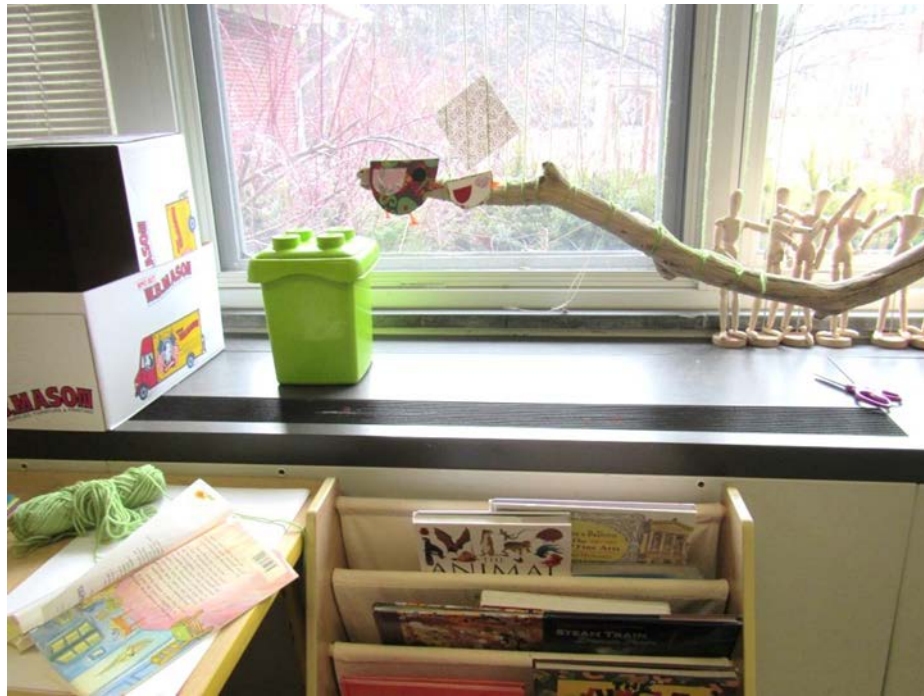
Picture 1

Fresh air is provided by a combination of unit ventilators (univents) located in individual classrooms either along the outside wall (Picture 1) or on the ceiling. Rooftop air handling units (AHUs) serve central areas such as the gym and cafeteria as well as supplement fresh air in some classrooms. The unit ventilators draw fresh air through a vent on the outside wall or roof. Air is mixed with return air from the room, filtered, heated (if needed) and delivered back to the room ([Figure 1](#)). Air from the AHUs is filtered, heated and delivered to rooms via ducted supply vents (Picture 2). Exhaust vents are located on the walls or ceilings of classrooms (Picture 3) and are ducted to fans on the roof. Additional exhaust vents are located in toilet rooms and areas, such as kitchens and the kiln room, which produce pollutants.

Items were observed hanging above a univent in one classroom (Picture 1) which can allow accumulated dusts to be reaerosolized. Several pencil sharpeners had spilled debris on the surface next to them (Picture 6). Pencil shavings can be an irritating dust, and care should be taken not to spill the shavings when the sharpeners are emptied, and cleaning up afterward.

Unit ventilator (univent); note items hanging above it and partial obstruction of front

1. Continue with regular filter changes and cleaning of univents and AHUs. Keep front and top clear of blockages.
2. Avoid hanging anything above univents or placing items on top of them which block airflow or may lead to distributing dust and odors.

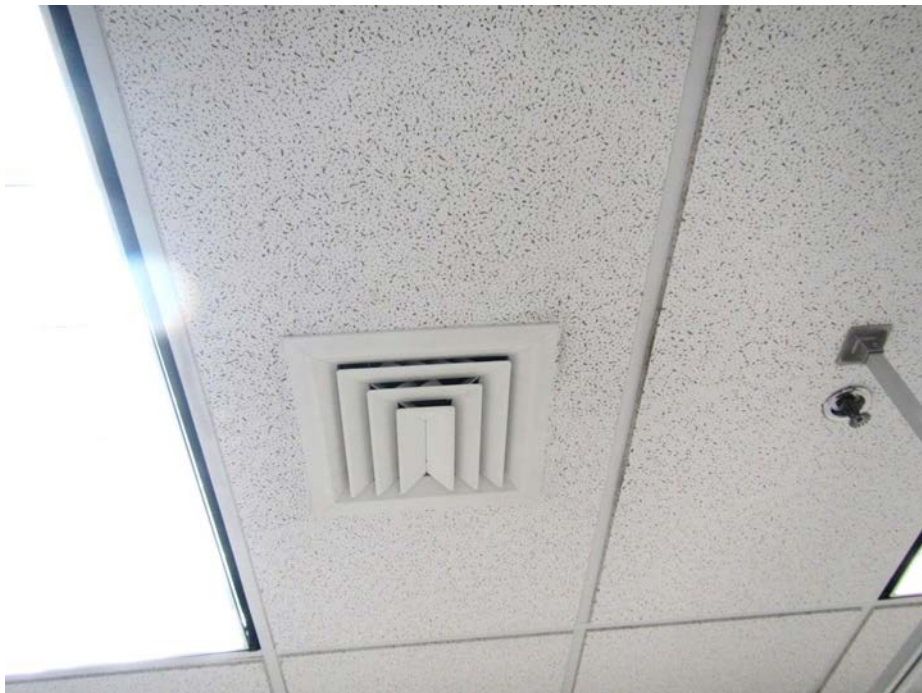
Picture 2

Supply vent

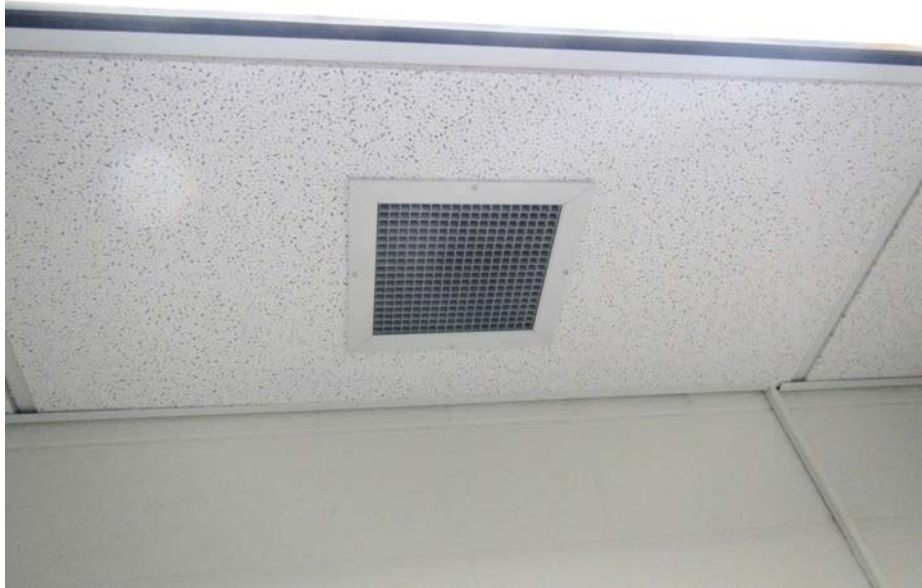
Picture 3

Ceiling-mounted exhaust vent

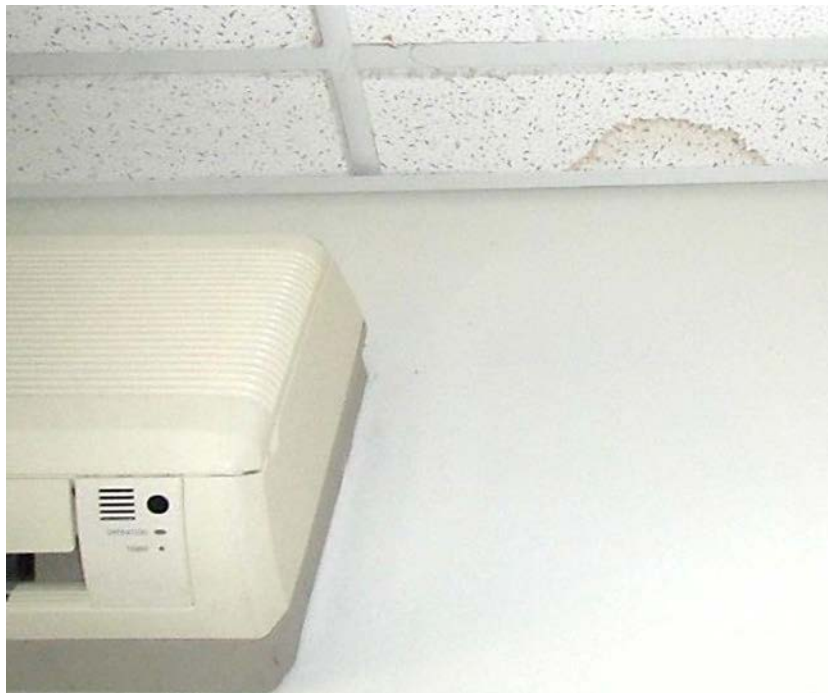
Picture 4

Two water-damaged ceiling tiles were observed (Table 1; Picture 4) which indicate leaks from the building envelope or plumbing system. These tiles should be replaced after the leak is found and repaired.

Water-damaged ceiling tile

3. Repair leaks and replace water-damaged ceiling tiles.
4. Properly maintain aquariums and plants to prevent odors and water damage.
5. Reduce use of products and appliances that create VOCs and use in well-ventilated areas.

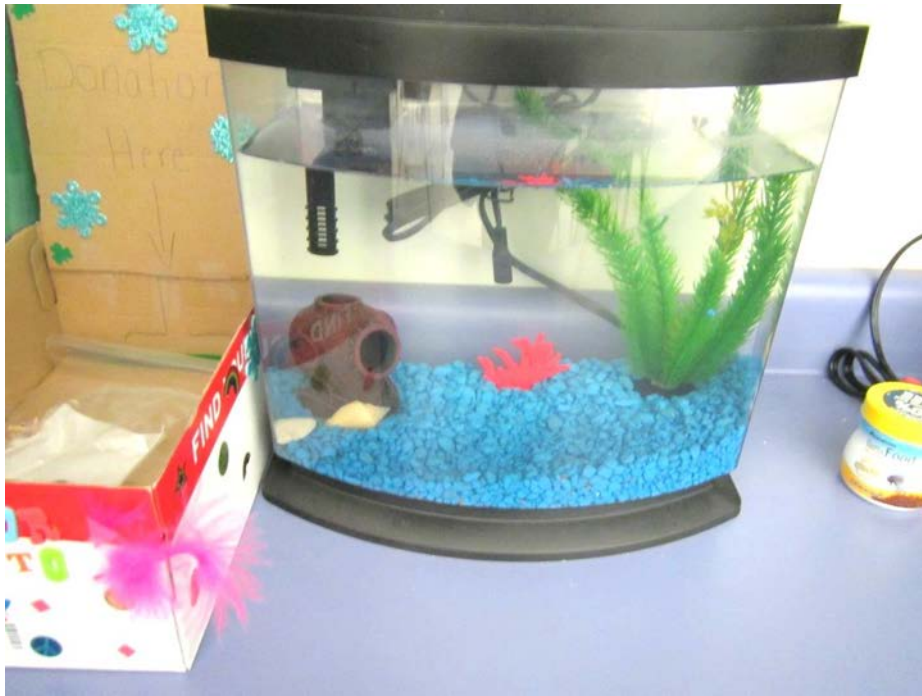
Picture 5

Plants were observed in a few areas (Table 1). Plants can be a source of pollen and mold, which can be respiratory irritants to some individuals. Plants should be properly maintained and equipped with drip pans and should be located away from air diffusers to prevent the aerosolization of dirt, pollen and mold. A small aquarium was found in a classroom (Picture 5). Aquariums should be kept clean to prevent odors.

Small aquarium

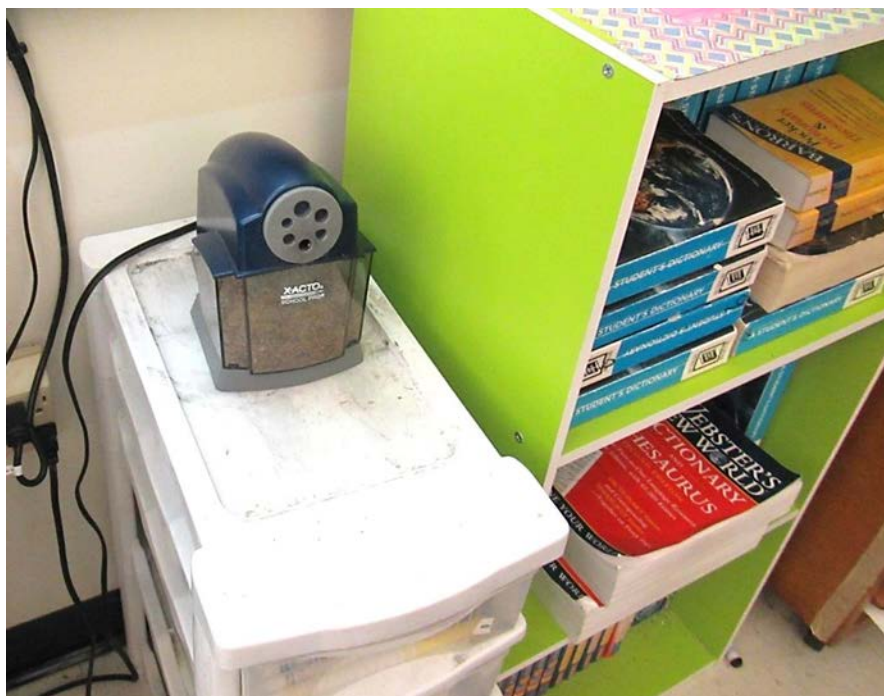
Picture 6

Pencil sharpener and spilled debris

6. Clean pencil sharpeners carefully to avoid spilling shavings.
7. Clean carpeting and area rugs regularly and discard those that are worn out or too soiled to be cleaned.

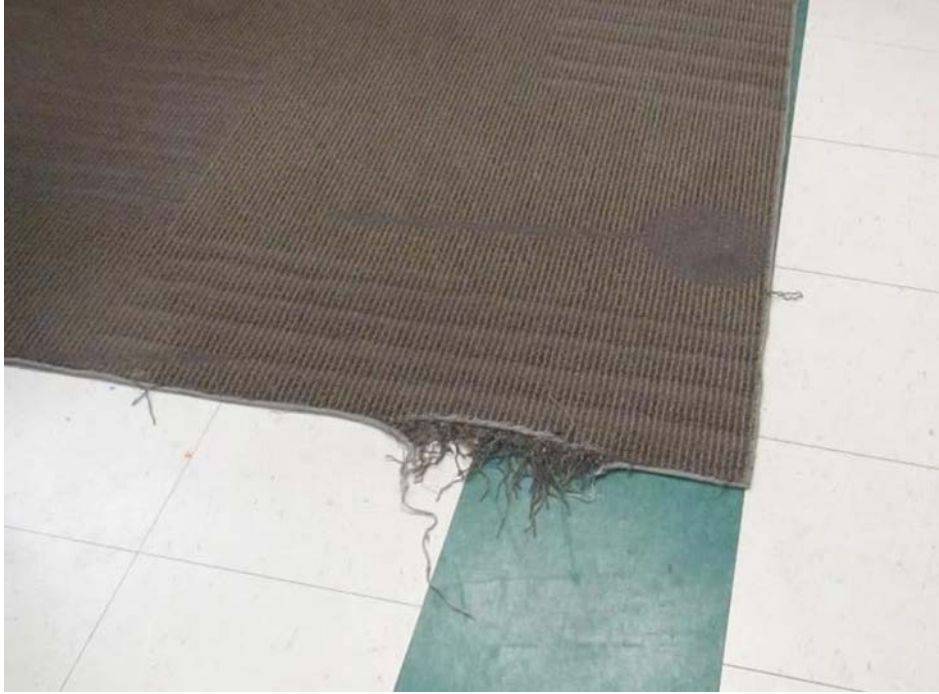
Picture 7

Some personal fans, supply and exhaust vents were observed to be dusty (Table 1). In some areas, items were observed on the floor, windowsills, tabletops, counters, bookcases, and desks (Table 1). Most classrooms had area rugs, which should be cleaned regularly. One area rug was significantly frayed (Table 1; Picture 7), which can be a source of dust as well as a tripping hazard. This should be repaired or replaced.

Frayed area rug
